System Failure Case Studies

MAY 2008

Volume 2 Issue 4

TWO RODS DON'T MAKE IT RIGHT

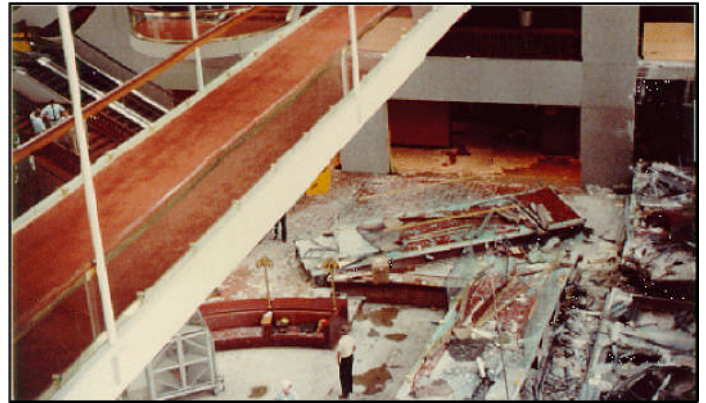
On July 17, 1981, nearly one year after its completion, the Hyatt Regency Hotel in Kansas City, Missouri filled its lobby with guests participating in and watching the evening “tea dance.” Suspended above the lobby were concrete walkways designed to connect both sides of the 2nd, 3rd, and 4th floors. Shortly into the dance, two of the walkways, packed with spectators, collapsed onto the crowded atrium floor below (Figure 1). The event was triggered by a failure in the connection between a supporting rod and the box beam of the fourth floor walkway. This disaster killed 114 people and injured approximately 200 more, which at the time was the deadliest structural collapse in U.S. history.

Figure 1: Pieces of the collapsed walkways in the atrium.

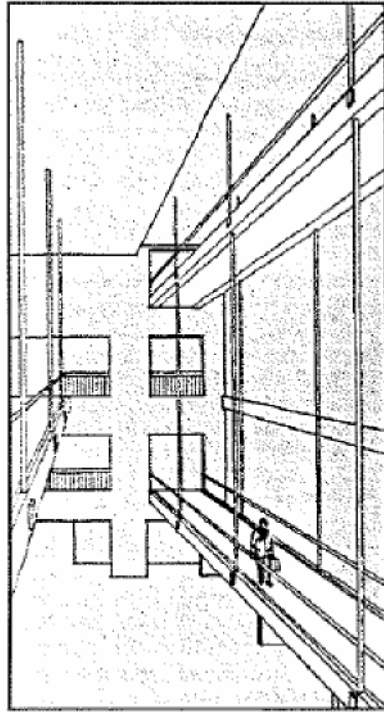
The initial planning for the Hyatt Regency Hotel began in 1976. The basic elements of the hotel design consisted of a 750 guest-room tower, a top-floor revolving restaurant on the 45th floor, and a four-story open atrium. Suspended across the atrium were three hanging walkways connecting opposite sides of the 2nd, 3rd, and 4th floors. The 2nd floor walkway was placed directly below the 4th floor walkway as shown in Figure 2.

Figure 2: Hanging walkways.

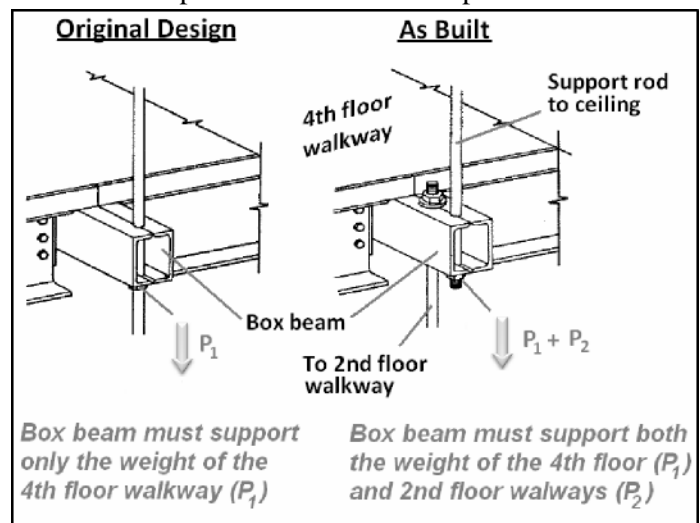
In order to implement the primary structural drawings, the fabricator, Havens Steel, would have had to thread the entirety of the steel rods below the 4th floor in order to screw on the nuts to hold the 2nd floor walkway in place. To simplify the process, Havens altered the design to a two-rod system, where the rods from the 2nd floor would attach separately to the 4th floor beams, and the 4th floor rods would attach to the same beams and connect to the roof (see Figure 3). This change was intended to make fabrication

and connection of the steel rods easier and faster. However, this essentially doubled the load on the 4th floor walkway beams, as these beams now supported the 2nd floor walkway as well. In effect, this design change resulted in a new load path which introduced a compounding shear stress element to the 4th floor walkway box beam.

Figure 3: Single-rod design versus two-rod modification.

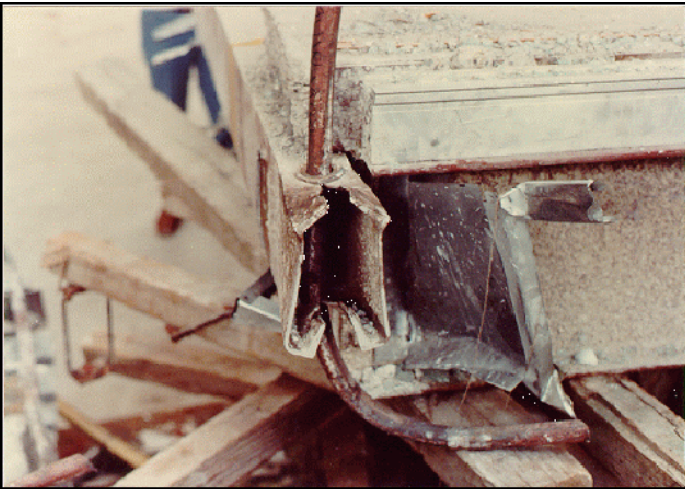
A year after the grand opening of the hotel, in 1981, during the evening “tea dance,” spectators noticed slight movements and swaying of the hanging walkways. Within moments, one of the connectors on the 4th floor walkway failed, as the weight of the 4th and 2nd floor walkway separated the box beam and pulled the beam loose of the nut and washer of the support rod. The jolt of the connectors breaking free caused a progressive failure of each of the remaining five connectors. As the 2nd floor walkway was attached to the 4th floor walkway, they both crashed down onto the crowded atrium floor below. Figure 4 shows the warped beam after the collapse.

An investigation by the NBS after the incident determined that the proximate cause of the collapse was a failure of the walkway box beam at a support rod connection. The box beam split open along the weld, allowing the nut and washer on the support rod to slip through the beam. In fact, the box beams on the 4th floor had already begun to yield even before the increased weight by the spectators. The weld on the 4th floor box beam had ruptured, allowing the beam to further yield and bend upward under the weight of the two walkways. The bending of the metal went far enough to allow the nut and washer to slip through the beam and break free. Once the first connection failed, the others failed almost immediately after.

G.C.E., the structural engineering design contractor, created only a partial design and left the most safety-critical design decisions to the fabrication/installation contractor, Havens Steel. Havens created the design without any documented engineering analysis and submitted it to G.C.E., who approved the design, without any documented engineering analysis either. NBS investigators were unable to find any significant recorded calculations of safety factors or yield strengths of the walkway connections. After weighing sections of the collapsed walkways, viewing footage of the crash, and re-creating sections of the walkways, NBS investigators determined that the load capacity on each connector was approximately only 60% of the Kansas City Building Code's required load capacity for that type of connection.

Figure 4: Ruptured box beam on the collapsed walkway.
